DIAGNOSTIC TIP: POSSIBLE CRANK NO START OR EXTENDED CRANK AND POTENTIAL DTC P0014 P0017 P0365 P0366

#PIP5598D: Diagnostic Tip: Possible Crank No Start Or Extended Crank And Potential DTC P0014 P0017 P0365 P0366 - (Apr 23, 2021)

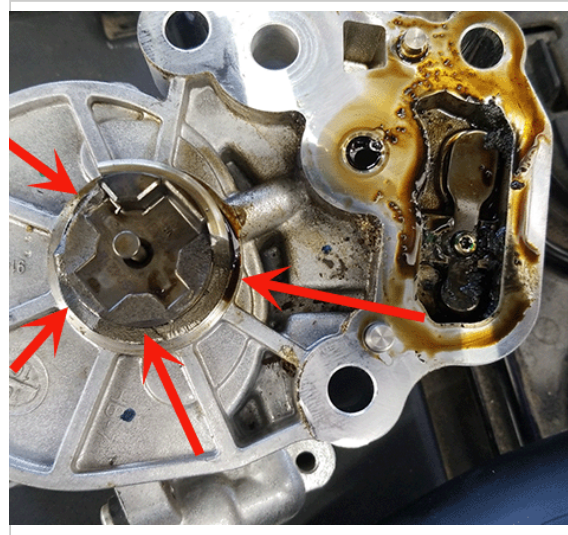
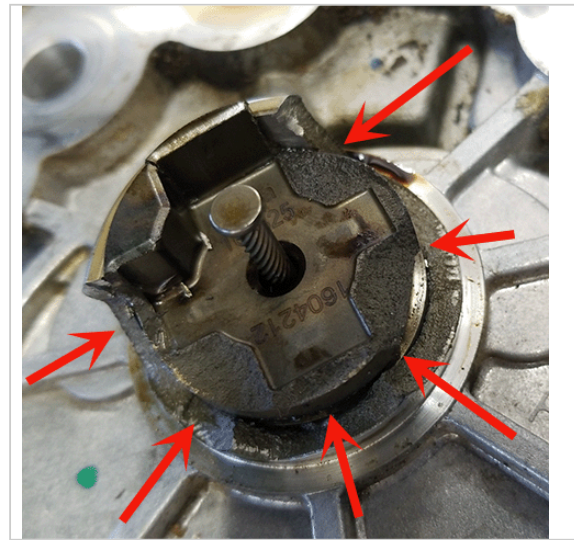
Remove cam cover assembly and perform steps below to confirm exhaust camshaft reluctor orientation. During disassembly the vacuum pump drive lugs should also be inspected for damage. (Photo below show damaged vacuum pump drive lugs)

If you find the vacuum pump drive lugs are broke and/or the exhaust camshaft reluctor is out of position then replacement of the exhaust camshaft and vacuum pump will be required.

Note: If needed, It will also be necessary to locate and remove the broken vacuum pump drive lugs and other metal debris during repairs.

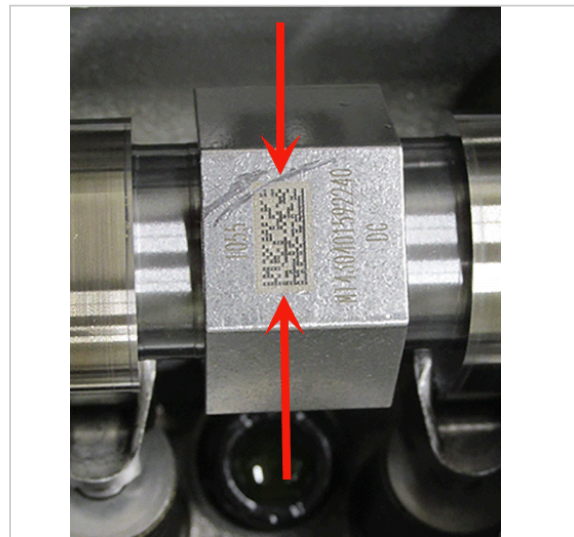
Rotate the exhaust camshaft to position the 2D matrix marking on the camshaft hex in the 12' o'clock position. (Reference photo below for 2D marking.)

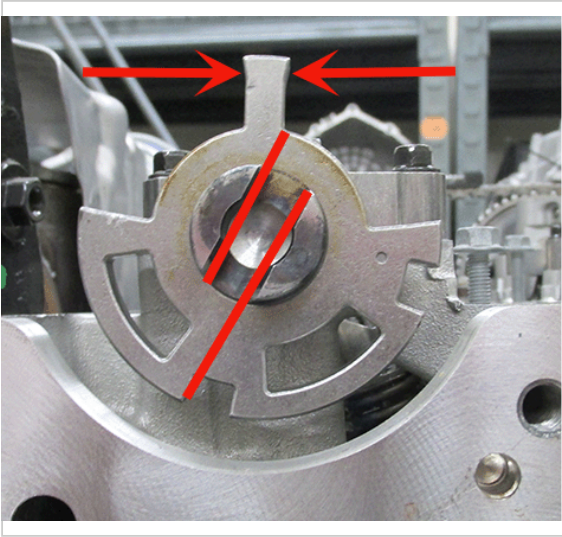
Once the exhaust camshaft 2D matrix has been positioned at 12' O'clock. Verify the small tang located on the camshaft reluctor ring (Arrows below showing tang on reluctor) is inline with the 2D matrix marking. Also shown are additional reference points used to verify exhaust cam reluctor orientation to camshaft.

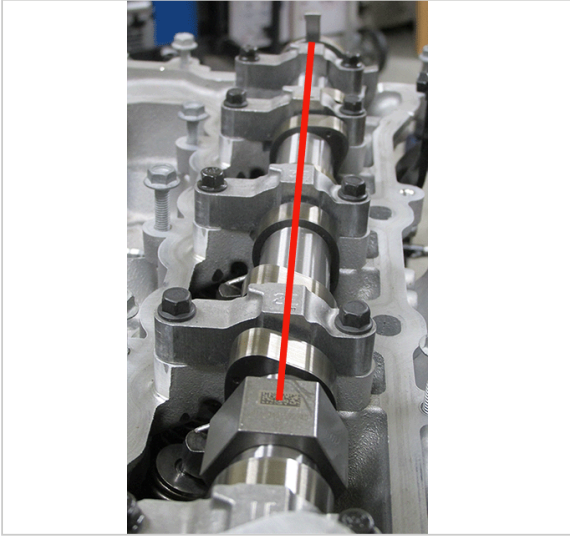
Photo below is showing the proper relationship between the 2D matrix marking and the small tang on exhaust cam reluctor wheel.
