# Tech Tips!

Volume 1  
Issue 1

May 2011

## Case Study: 2002 Chevy Express P0300

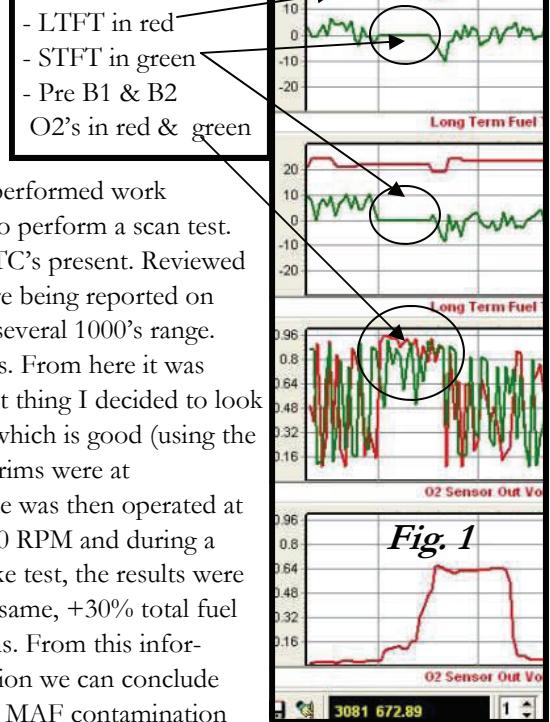
**Test Results / Repair;** DTC P0300 set as a current DTC. No other DTC's present. Reviewed freeze frame data and determined DTC set shortly after cold startup. Misfires were being reported on cylinders 7 and 8 during idle, the misfire history counters for 7 and 8 were in the several 1000's range. As the vehicle was brought off idle the misfire would scatter to the other cylinders. From here it was necessary to determine if the air and fuel delivery systems were a suspect. The first thing I decided to look at was the air density system (MAF). The MAF air flow reported 6.2gm/s at idle which is good (using the 1gm/s per liter analogy). Next , a review of fuel trims was performed. Total fuel trims were at approximately +30% (anything above 10% is considered out of range). The engine was then operated at

2500 RPM and during a brake test, the results were the same, +30% total fuel trims. From this information we can conclude that MAF contamination and vacuum leaks are not likely suspects (a propane enrichment leak test was still performed). Next a fuel pressure gauge was installed. Fuel pressure was at 62 psi (spec 60-66). The vehicle was then taken on a test drive to quickly determine if fuel volume was adequate. This was done by using the EASE scanner's graphing capabilities. Looking at **Fig. 1** we can see the relationship between fuel trims and oxygen sensors. To test for fuel volume the vehicle was operated under WOT conditions which puts the PCM into
